SUSQUEHANNA RIVER BASIN

EATON BROOK RESERVOIR DAM

INVENTORY NO. N.Y. 352

**PHASE I INSPECTION REPORT
NATIONAL DAM SAFETY PROGRAM**

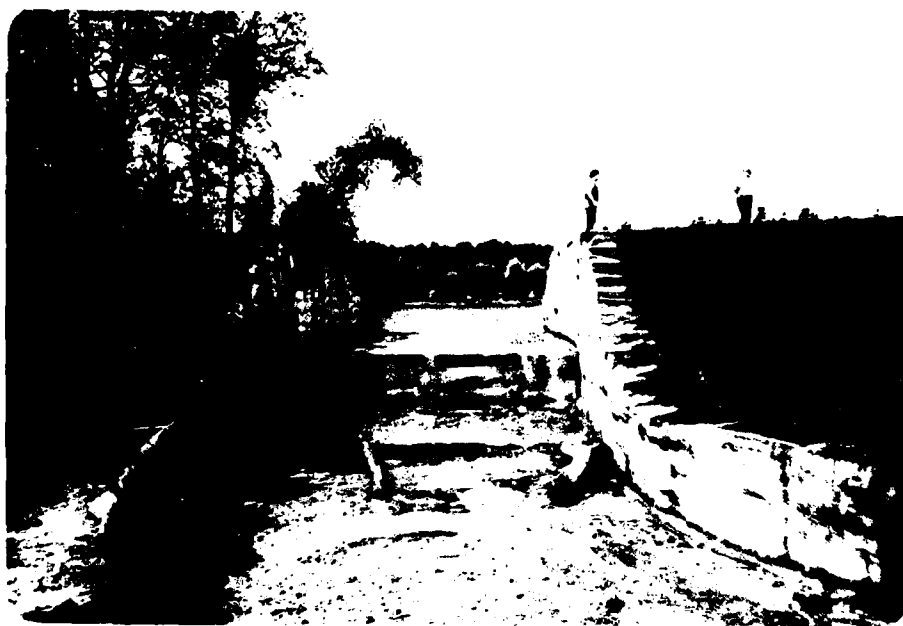
Auxiliary spillway crest - looking upstream

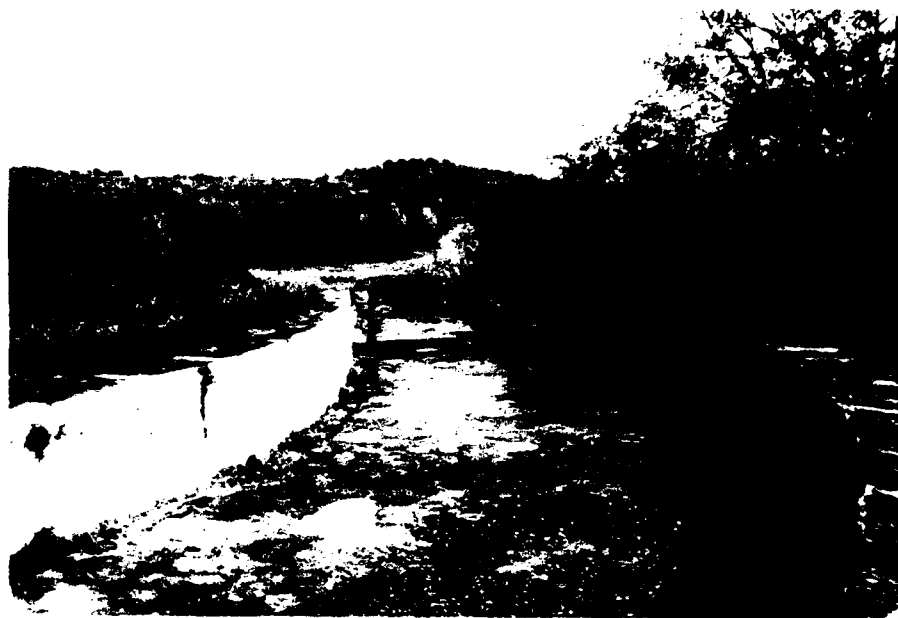
The auxiliary spillway channel was in satisfactory condition. Portions of the sidewalks and channel bottom have recently been mortared and repointed. Some sections still need to have these repairs made. Voids several inches deep were noted in the sections which needed repointing. Seepage was noted emerging from one of the steps near the downstream end of the dam. Based on the location of this seepage, it appeared to be caused by a spring from the hillside.

Auxiliary spillway channel looking downstream

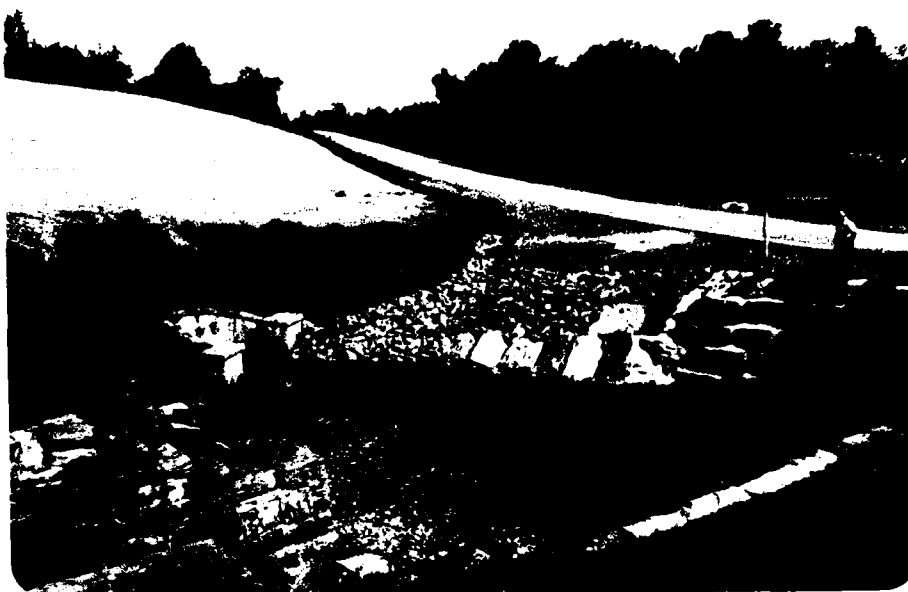
The outlet channel was in satisfactory condition. Immediately downstream of the outlets to both the service and auxiliary spillways, the stream passes under County Route 86 in an 8 foot diameter corrugated metal pipe. This pipe was recently installed replacing a smaller pipe. Downstream of the pipe, the channel was lined with rip-rap for approximately 50 feet. Beyond that point, the natural channel

Outlets to service spillway conduit and auxiliary spillway channel
